STUDY ON ASPHALT PAVEMENT DISTRESS: A CASE STUDY IN TURKISH REPUBLIC OF NORTHERN CYPRUS

Dr. Rustam Hafizyar¹, MSc. Sayed Dawood Karimi²

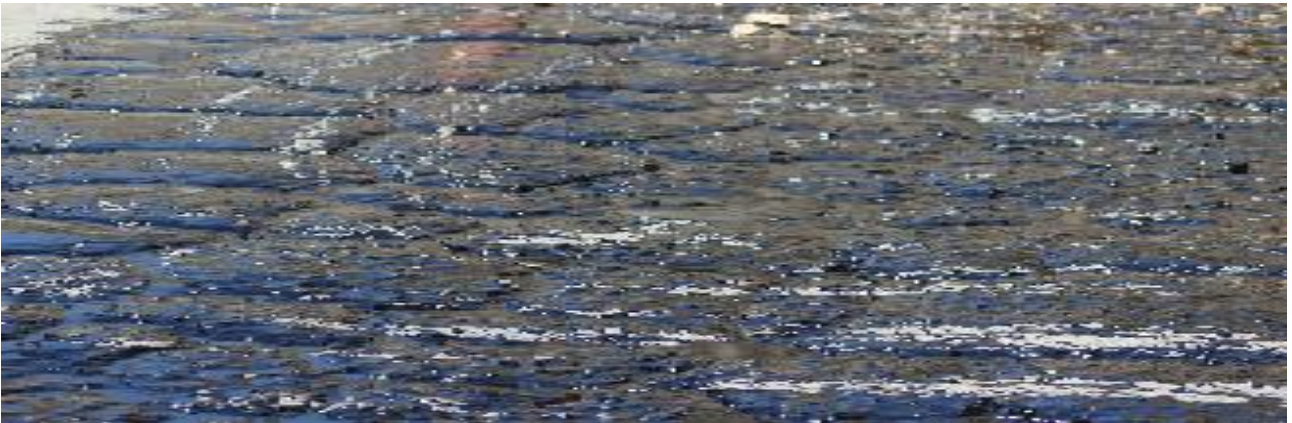
This crack is also defined as a fatigue crack. At first, when it appears on the pavement surface, it looks like longitudinal cracks in the wheel paths but after growing and advancing, it interconnects and looks like an alligator crack though finally, it shows potholes (Hadjidemetriou & Christodoulou, 2019). As shown in Figure 1. There are many factors causing this crack like heavy traffic, base course, insufficient surface, subgrade strength, thin surface, poor drainage which causes penetration to the subgrade and base course and destroy the pavement (Bianchini et al., 2010).

Fig. 1: Alligator crack in flexible Pavement

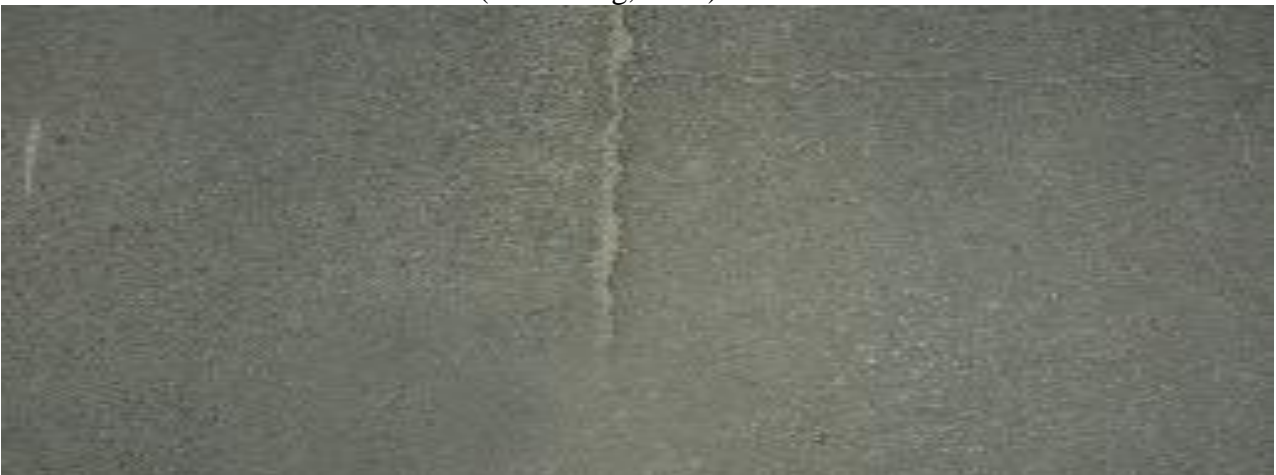
There are some fractions that are mostly appearing in the centerlines of the pavements which is called longitudinal cracks (Lan & Chang, 2019). As shown in Figure 2. Climate affects the shrinkage of the asphalt layer and it helps these cracks to grow. At the same time joining two sections of the pavement with a poor construction is another cause and temperature cycling or unfair operations on the paver could be the reasons for these cracks (Li & Yang, 2019).

Fig. 2: Longitudinal crack in flexible Pavement

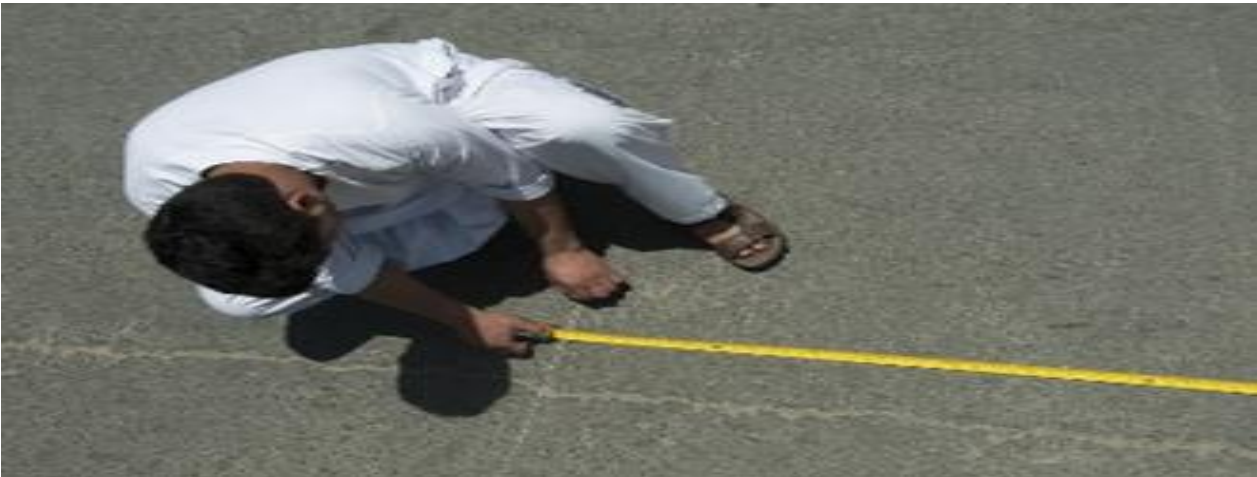
These cracks are mostly happening in a perpendicular direction to the centerlines and would not locate on Portland where cement and concrete joins as shown in Figure 3. It also can appear on the surface (Yang & Deng, 2019). Some causes of these cracks are: wrong set up of the asphalt mixtures, low temperature and sub-base of pavement layers (Yang & Deng, 2019).

Fig. 3: Transverse crack in flexible Pavement (Hafizyar & Mosaberpanah, 2018).

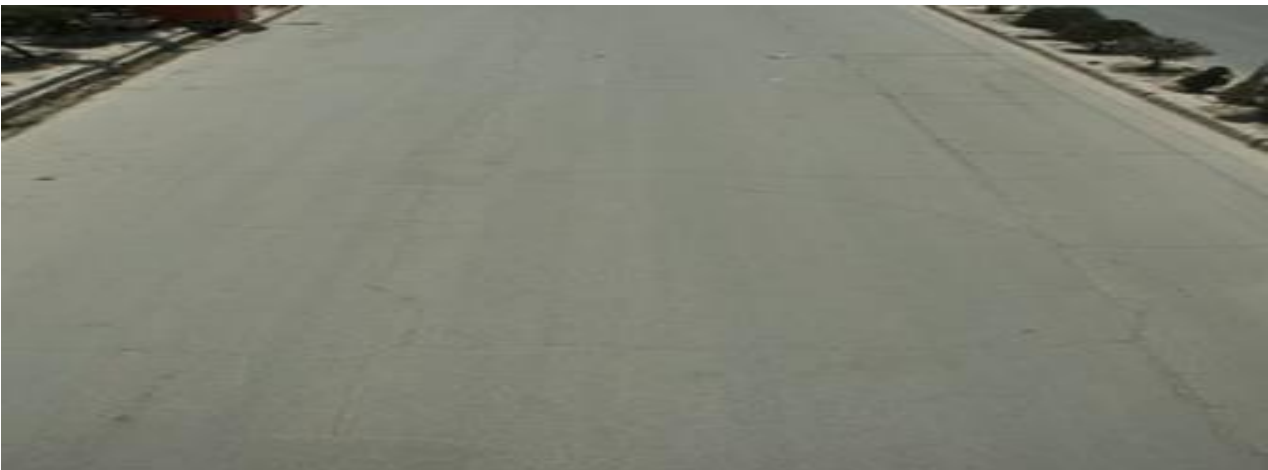
Block cracking happens unlike other cracks specifically alligator cracks, they are a collection of interconnected rectangular peaces which could be all throughout the width of the pavement not just in the wheels paths as demonstrated in Figure 4. If the severity is low in these cracks, it is possible to repair and fix it with a “thin wearing course”. But high severity may need overlay and recycling. The causes are proved to be aging, oxidative hardening of the Asphalt Concrete (AC), wrong binder mixture, high void content, shrinkage and temperature cycling (Osmari et al., 2019).

Fig. 4: Block crack in flexible Pavement

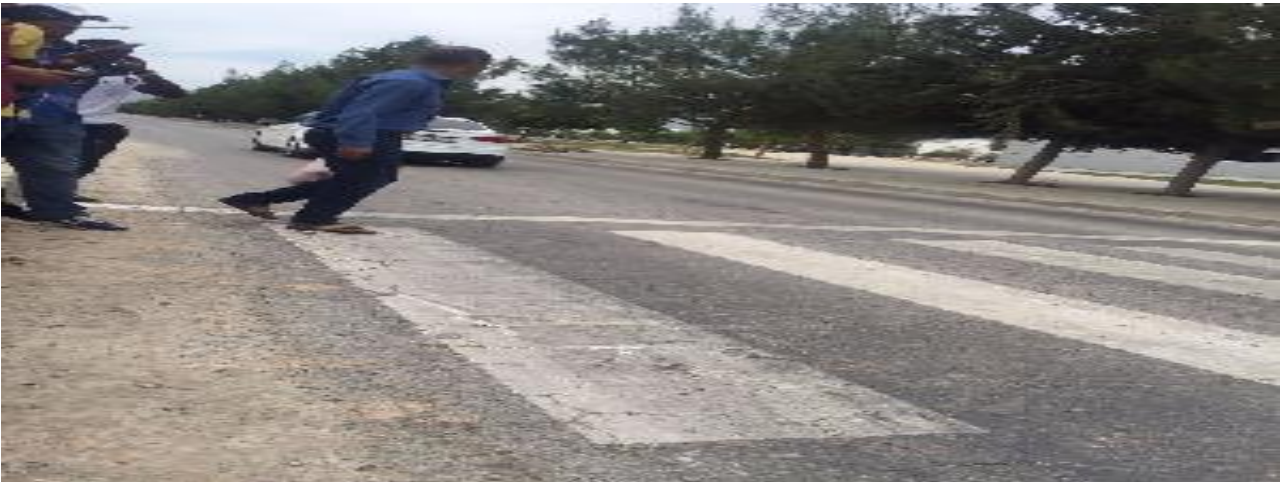
Distress in narrow pavements are edge cracks which start from the edge and extends, it looks similar to fatigue cracks. They happen because of weak material or excess moisture which is not supporting the shoulder of the pavement well as demonstrated in Figure 5. Causes are different according to the pavement situation. For instance, it could be from poor drainage which the water is near to the edge, soil movement beneath the pavement, heavy traffic close to edge, infiltration of water to the base, lack of strength in surface and base (Nega, 2015).

Fig. 5: Edge crack in flexible Pavement

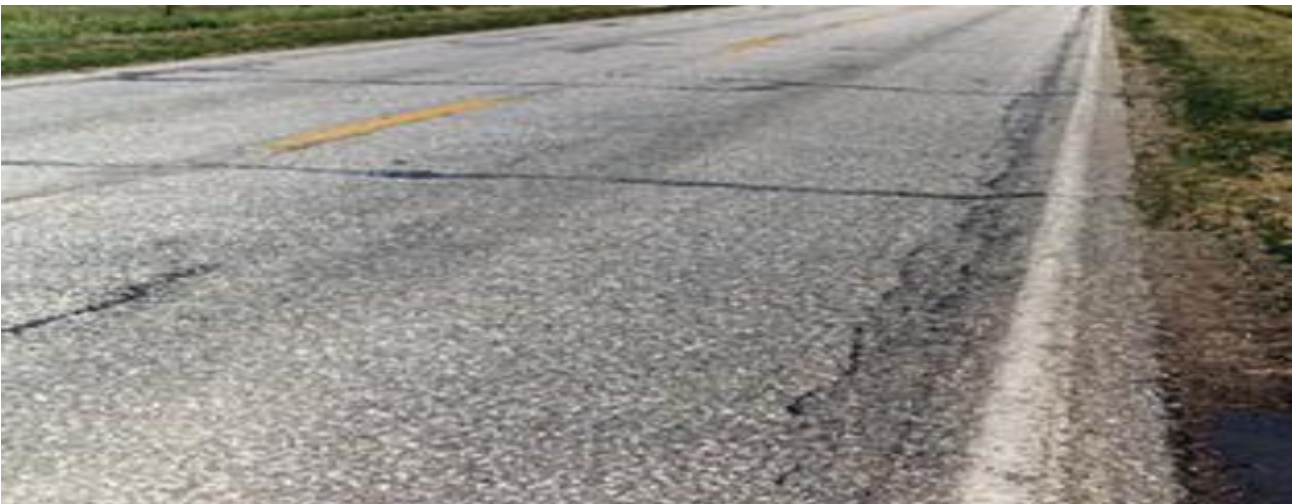
Depression of the longitudinal surface in wheel path is rutting which deteriorate the asphalt and cause other cracks. It is actually a surface failure which holds water in the wheel path (Vaitkus, 2014). A wide narrow crack shows a subgrade failure as demonstrated in Figure 6. It is possible to say that causes are low air voids, too much dust, rounded aggregate, high asphalt content, and too much natural sand (Zhang et al., 2019).

Fig.6: Rutting crack in flexible Pavement

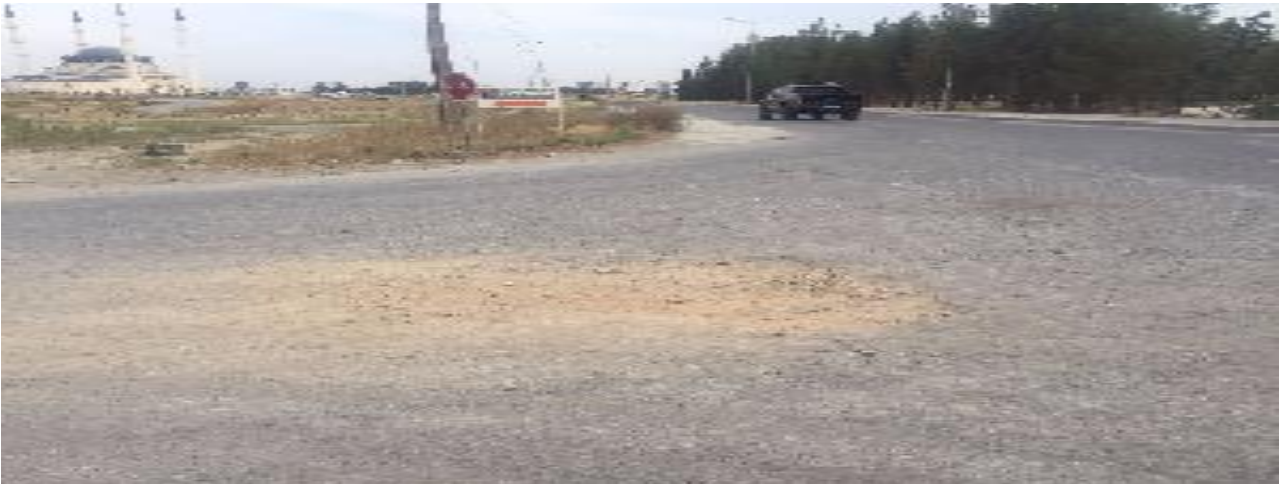
There are holes like depressions in a bowl-shape, which is a progressive failure and called pothole. A tiny piece of the first layer is destroyed and gradually distress goes down to other layers in the bottom of the pavement as demonstrated in Figure 7. The causes are a lack of pavement thickness to handle traffic in freeze or thaw times. Meanwhile, Poor drainage as others, raveling of cracks which cause pothole. They can be repaired with rebuilding or excavating, the repaired area may require immense potholes (Yadav et al., 2019).

Fig.7: Pothole in flexible Pavement

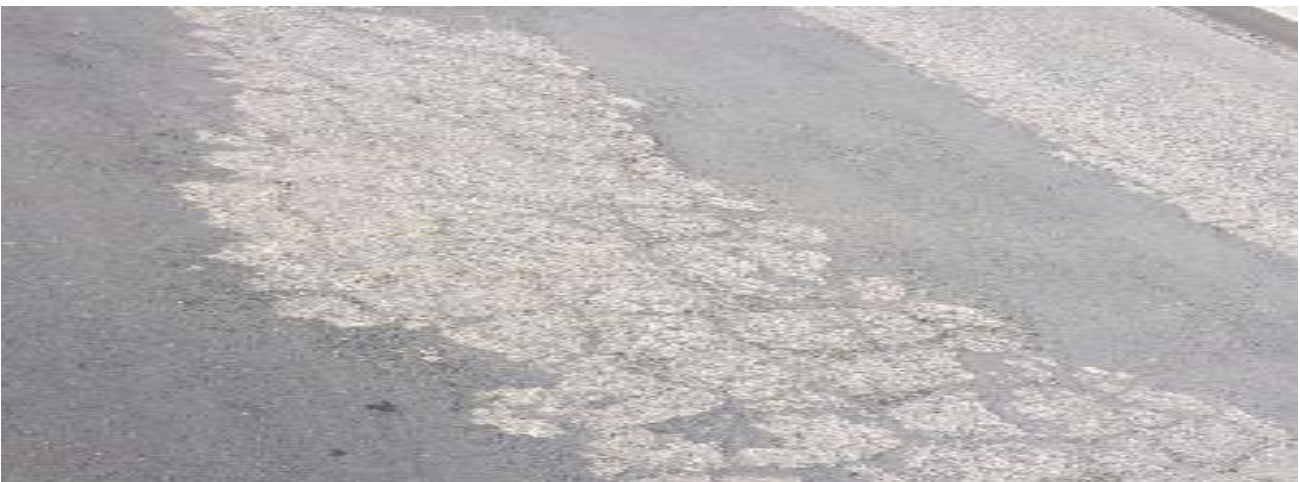
There are small pieces of asphalt pavement in the surface which is more than 0.1 square meters and they are replaced or their materials increased in a portion in the construction of pavement called patch deterioration as demonstrated in Figure 8. Several issues cause patching for instance when the original distress spreads, poor connection would be between the patch and existing pavement, wrong compaction while patching, wrong material mixing, and rut settlement appealing at the perimeter or inside the interior side of the patch (Thant & War, 2019).

Fig.8: Flexible pavement Patching sample

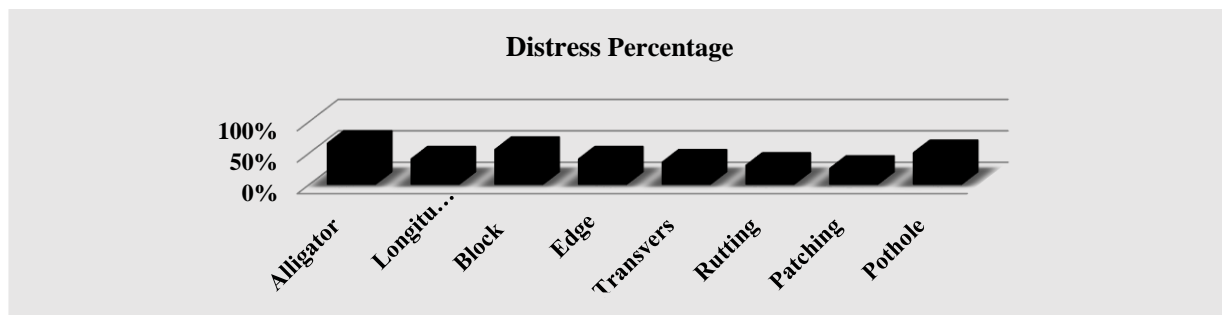
The magnitude of each section covered with distresses were specified and compared with total area that was damaged. In Figure 10 as shown the percentage of distresses is calculated.

Fig. 10: Magnitude of each section covered with distresses

Result shows alligator crack severity in three sections of highway (H, H, M) covered the highway 60%, potholes severity in three section of highway (H, M, H) covered the highway 49%, block severity in three section of highway (H, M, H) covered the highway 56%, longitudinal crack severity in three section of highway (H, H, M) covered the highway 38%, transverse crack severity in three section of highway (H, M, l) covered the highway 35%, edge crack severity in three sections of highway (L, M, H) covered the highway 38%, rutting severity in three section of highway (M, L, L) covered the highway 30%, patching severity in three sections of highway (L, L, M) covered the highway 22%.

Based on the study findings, it is recommended to use crack filling and sealing, overlay, patching and shoulder improvement due to the others treatment alternative is not available there.
